Marine growth sampling tool evaluation

Evaluation of the performance of an ROV-mounted tool for sampling marine growth on offshore energy structures

Joop Coolen, Jan-Jelle Huizinga, Kennisdag Wozep – MONS 25 maart 2025

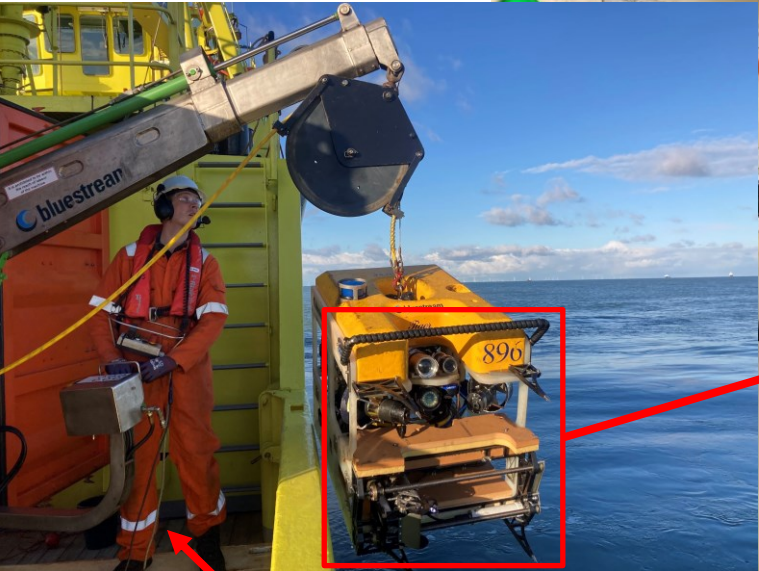
MGS-tool

20 ft container on deck

ROV

TOOL

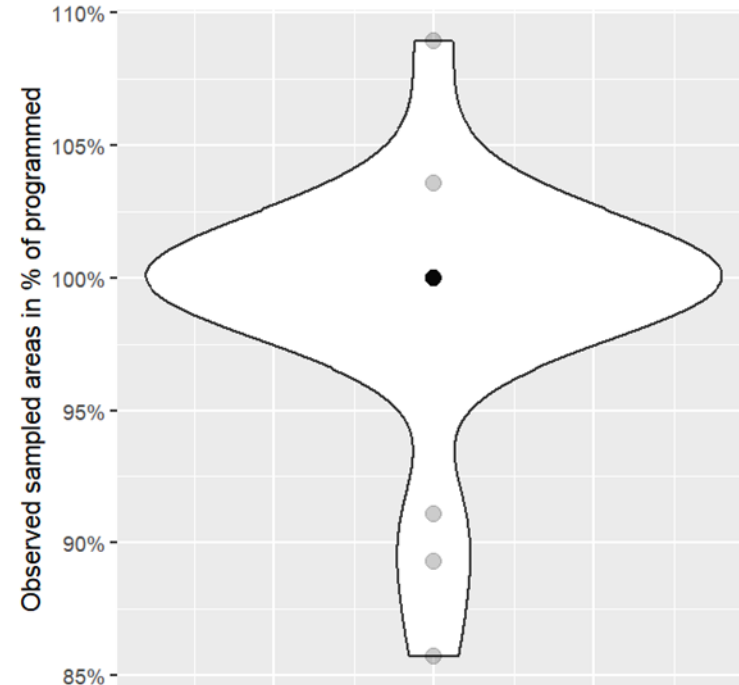
Results: Field test

- Planned sampling area was 560 cm²
- Actual area varied 480 – 610 cm²
- 16 samples exactly 560 cm²
- Average deviation was 1%

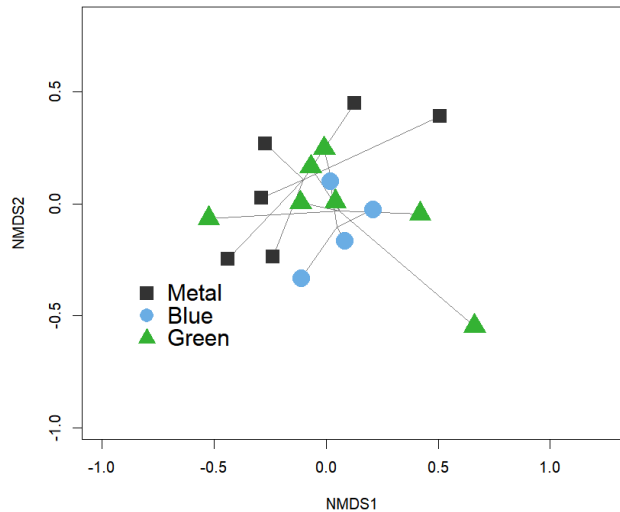
Results: taxonomic labwork

- Some non-significant difference between knife types (high variation)

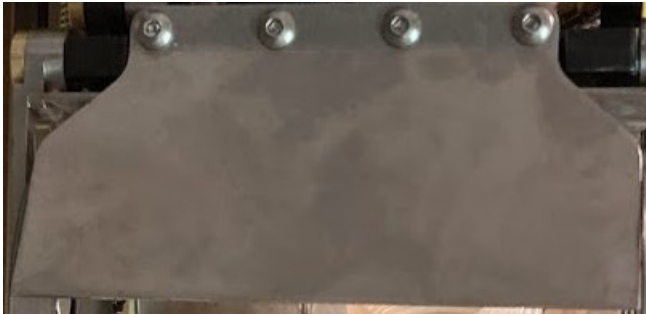
Results: Field test

- 3 types of scrapers all took similar samples
- Softer plastic scrapers damaged faster than steel scraper
- No scraper type showed visual damage to coating
- No clear difference in fauna removal percentage

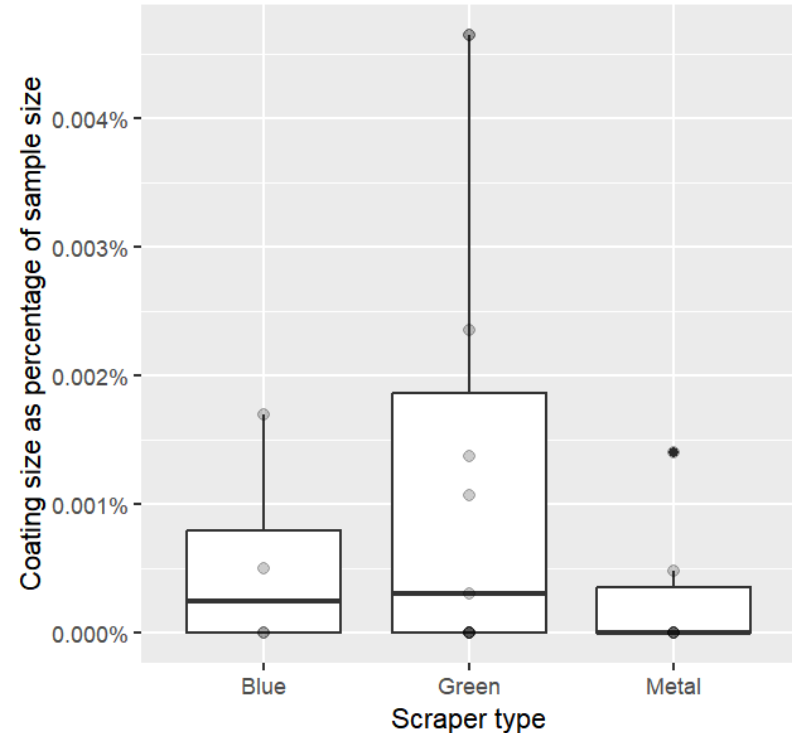
Results: coating labwork

- No clear difference between scrapers
- 0 – 0,0046% total coating particles compared to sampled area
